Structural Condition Assessment for

The Mine Tavern

14 Public Square
Nelsonville, OH 45764

Date: 2/15/2026

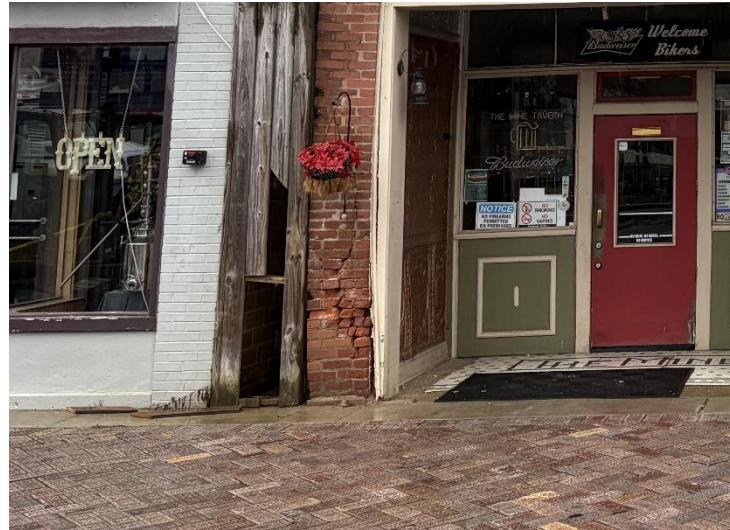
Photo #1

West (Front) Wall: The west wall exhibits multiple cracks, a severely corroded steel lintel above the primary entry, and deteriorated masonry at the brick jamb immediately north of the main entrance door. While the precise timing of crack development cannot be conclusively determined, the wall is considered structurally compromised and appears to possess minimal reserve load-carrying capacity. Please refer to Photos #1 and #2.

- The building should be immediately secured to prevent unauthorized entry.
- Adjacent buildings, as well as the sidewalk and roadway along the west side of the structure, should be closed until the hazard is mitigated.
- Immediate action should be taken to either shore and stabilize the structure or proceed with controlled demolition, with careful consideration given to the protection of adjacent structures.

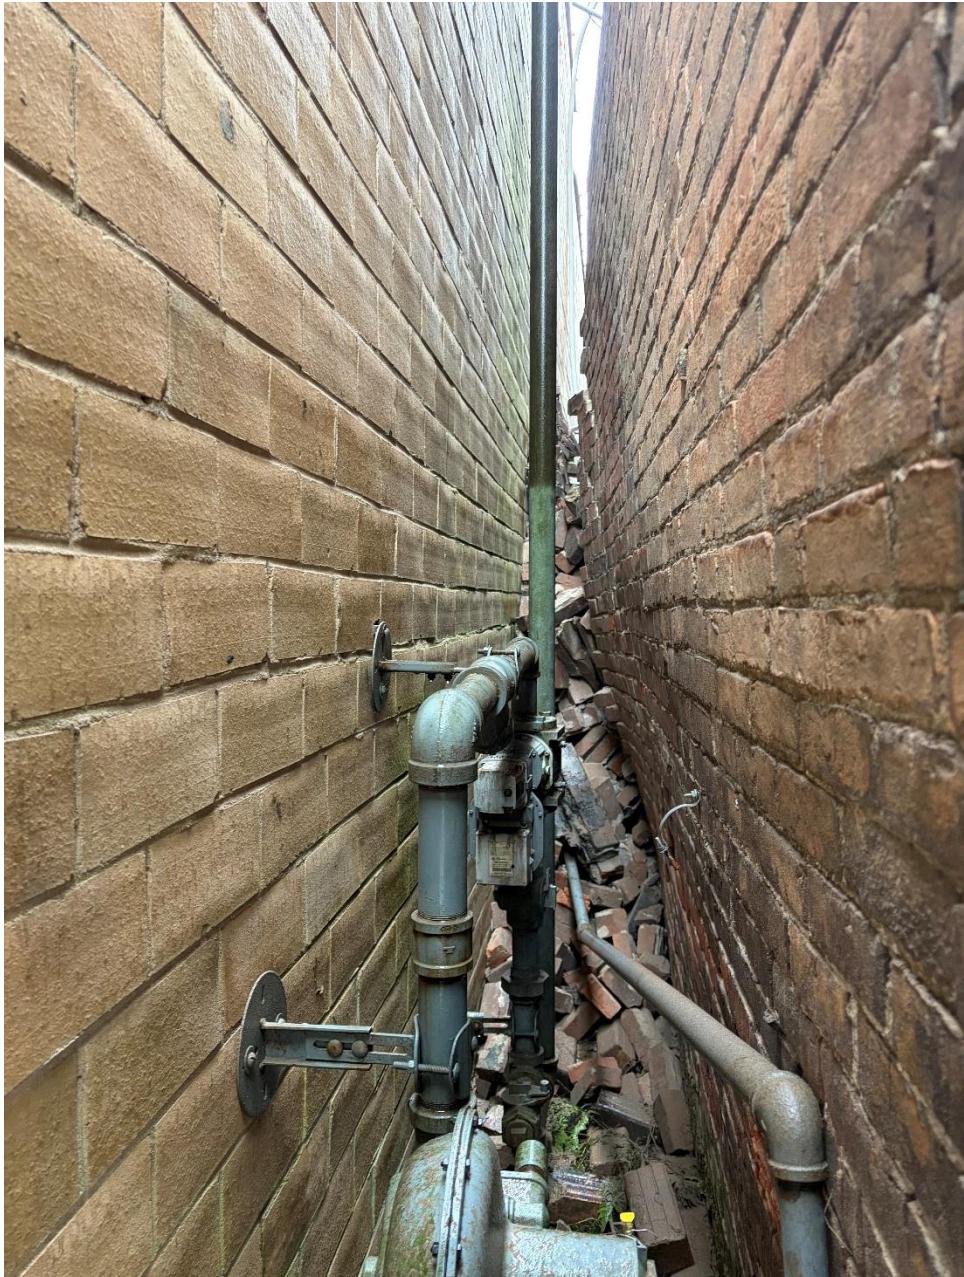
Photo #3

North Wall: A partial collapse of the north wall was observed, along with a remaining section of wall leaning toward the north. Based on the observed displacement and loss of structural integrity, further collapse of this wall is considered likely. Please refer to Photos #3 and #4

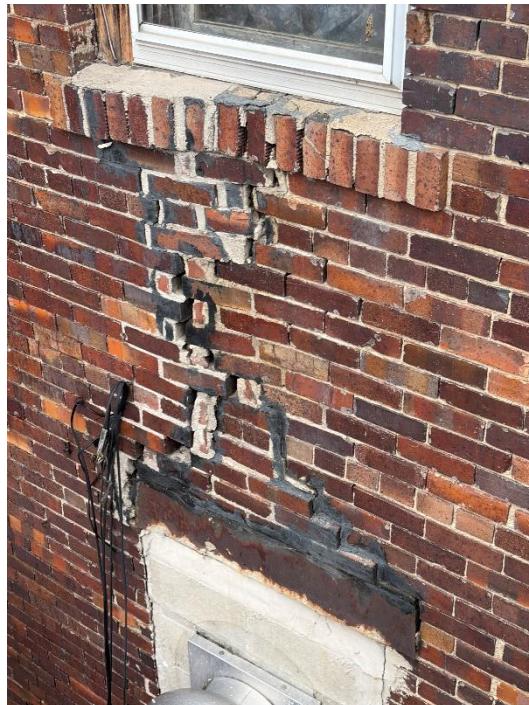
Photo #5

East Wall: The east wall remains largely intact; however, significant deterioration and separation between masonry wythes were observed, indicating a compromised structural state and reduced wall stability. Please refer to Photo #5.

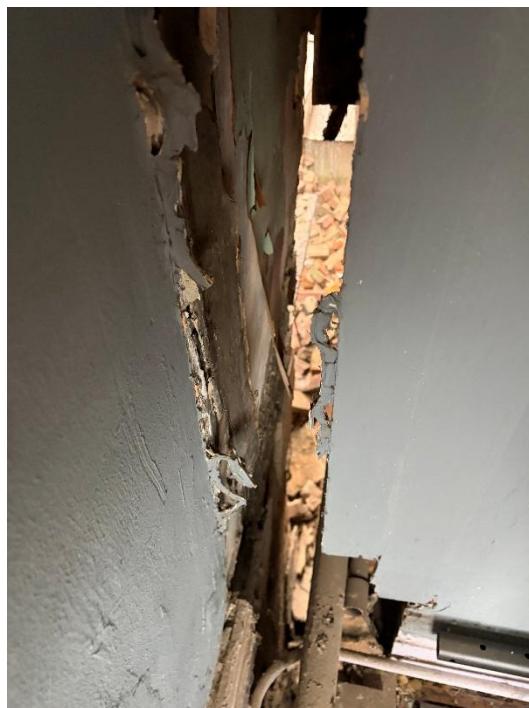
Photo #6

Floor and Roof Framing: Portions of the second-floor framing at the north end bearing are unsupported at the area of partial wall collapse and at adjacent areas where the wall has shifted to the north for an

estimated length of approximately 20 feet. Noticeable sagging and deflection were observed under minimal loading conditions, indicating a substantial loss of structural support. Please refer to Photo #6.
